The Effect of Absorbed Hydrogen on the Rotors of Steel Machining Products During Powerful Turbo Aggregate Repairs

Abstract: Rotor shafts are the most heavily loaded and accident-prone parts of powerful turbine generators, which are cooled using hydrogen. To eliminate damage sustained during operations, repair work was carried out, including the removal of defective parts, surfacing, and turning. This study tested the machinability of the rotor shaft using prototypes made from 38KhN3MFA steel. A section of the shaft was degraded due to prolonged operation (250 thousand hours), and compared to the central part, a decrease in the average grain size from 21.57 μm to 12.72 μm and an increase in the amount of hydrogen absorbed during operation from 2.27 to 7.54 ppm were observed. With the frequency of dry turning increasing from 200 to 315 RPM, the chips changed their form from mostly rectangular with linear dimensions of 10 to 20 mm to large spiral rings with a diameter of 15 to 20 mm and a length of more than 50 mm. Cracks of 1 to 4 mm in length were found in most chip particles at both rotational speeds. Increasing the rotational speed from 200 to 315 and up to 500 RPM led to the for

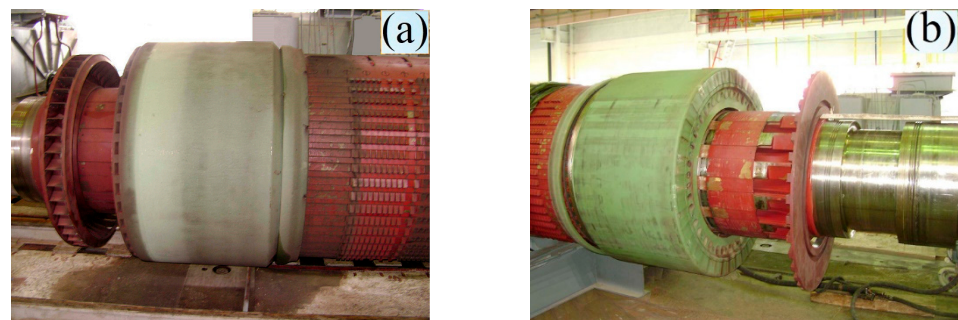
The rotor shaft consists of a middle active part (barrel) and two shanks. It is characterized by a single forging of steel from the high-strength category. To manufacture the shaft, an ingot about twice as large is used, which is the limit value for modern metallurgy. The large size of the shaft and the peculiarities of its operation lead to various operating situations that require repair work. In Figure 4, the appearance of the rotor shaft before and after repair work is shown.

Figure 4. Damaged (a) and repaired (b) turbogenerator rotor shaft before transportation to the NPP turbine hall.

The repair technology consisted of the fact that an insert made of the same material weighing up to 20 kg is mounted in place of the damaged material. “Sealing” is only part of the technological process of problem solving. Most attention is paid to the method of its installation on the rotor barrel and the proposed design of a special lock. The analysis of the durability of the structure under significant centrifugal forces arising during operation was taken into account.

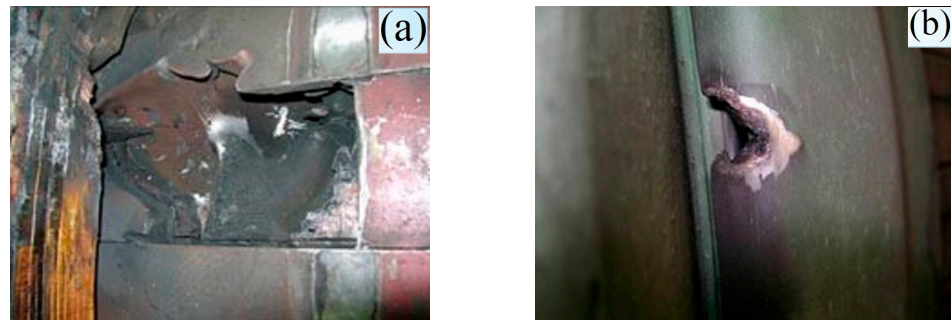
After 250,000 h of turbine unit operation, the hydrogen seals of the rotor shaft on the turbine side were destroyed. As a result of the friction of the fragments of the hydrogen seal against the tangential ridge, the shaft was partially destroyed (Figure 5). The boss bearings melted. The metallographic inspection showed that the rotor shaft metal in the hydrogen seal zone changed compared to the rotor shaft's metal, which did not come into contact with the hydrogen seal.

Figure 5. Damaged TGV-1000 shaft (after winding short circuit) in the hydrogen sealing zone. (a)—rotor body, (b)—retaining ring.

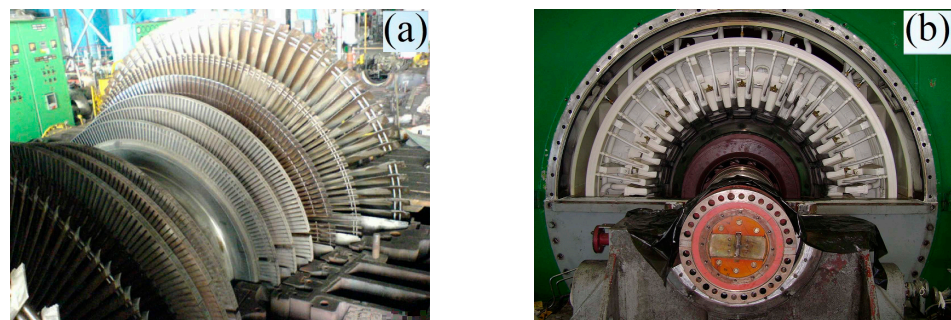
Figure 6. Rotor shaft of the turbine unit with damaged blades (a) and disassembled bearing (b).

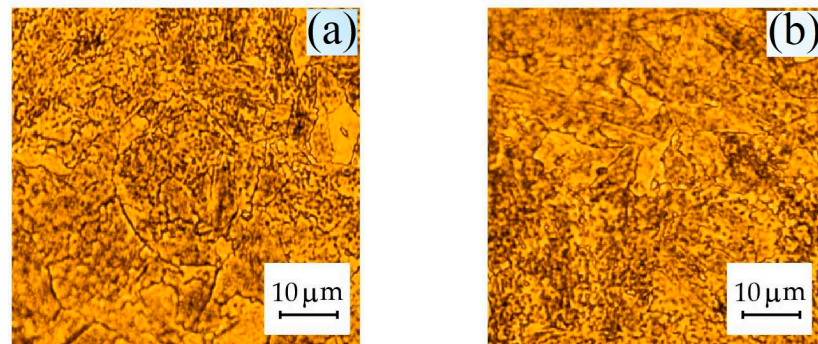
Figure 8. Microstructure on the rotor shaft surface (a,b). The initial conditional state from the rotor shaft surface (I—(a)). The state in the hydrogen seal zone (II—(b)).

For site I, the average grain size was $D = 21.57 \mu\text{m}$, and the variance was $\sigma = 63.88 \mu\text{m}^2$; for site II, the average grain size was $D = 12.72 \mu\text{m}$, and the variance was $\sigma = 54.27 \mu\text{m}^2$. The largest average values of the data shown in the histograms (the central columns through which the maximum (extremum) of the normal distribution 2D RVE passes) correspond to 6, 7, and 8 (Figure 9a) and 9, 10, and 11 points of grain size (Figure 9b) according to DSTU 8972:2019 [87]. After machining and obtaining chips from areas I and II, the amount of hydrogen was determined to be 2.27 and 4.72 ppm (Figure 10a,b).

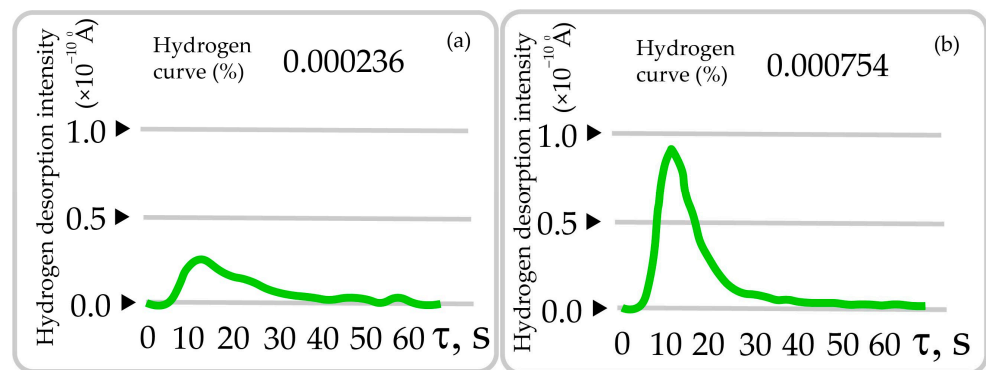
Figure 10. Amount of hydrogen in the chips (a,b). Initial conditional state of the rotor shaft surface (I—(a)); state in the hydrogen seal zone (II—(b)).

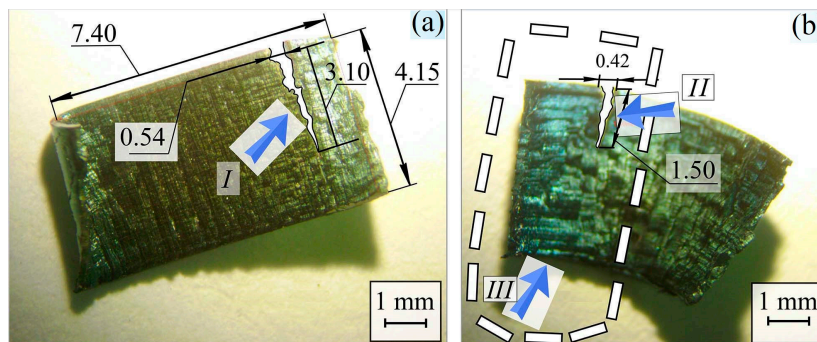
Figure 14 shows the appearance of the cut products: a rectangular particle (4.15 by 7.40 mm) with a crack indicated by arrow I (Figure 14a). The length of the crack is 3.10, and the width of the crack at the beginning is 0.54 mm. On the surface of the particle, the colors of variability are almost invisible. Figure 14b shows an image of a particle formed

under cutting conditions at 315 RPM. Arrow II indicates a crack with a width of 0.42 mm and a length of 1.5 mm; III indicates the left side of the chip, which shows the colors of the variability. The width of the cloves in this area is 0.37 mm, and for the rest of the chip, it is 0.32 mm.

Figure 14. Appearance of chips obtained under dry cutting conditions: 200 RPM (a) and 315 RPM (b). A rectangular particle (4.15 by 7.40 mm) with a crack indicated by arrow I. dotted frame—colors of the variability.

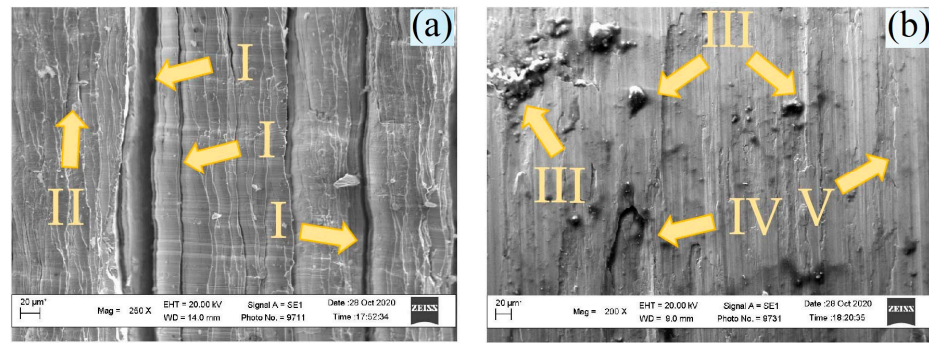
Figure 16 shows photos of the inner surface of the chip (corresponding to the chips shown in Figure 14). At 200 RPM, chips with stripes and vertical cracks were formed: position I (Figure 14a) had areas with small welded particles; position II had chips with welded particles of the material at 315 RPM (position III). The welded particles are larger in size and have a larger area compared to those shown in Figure 16a. Material delamination (position IV) and areas with microrelief (position V) were also observed, i.e., two different competing micromechanisms of fracture during chip formation were recorded. Thus, when the temperature rises, conditions are created for welding the material, which is accompanied by an increase in roughness.

Figure 16. Internal surface of chips (photo of chips from Figure 14a) at 200 RPM (a) and 315 RPM (photo of chips from Figure 14b) (b).

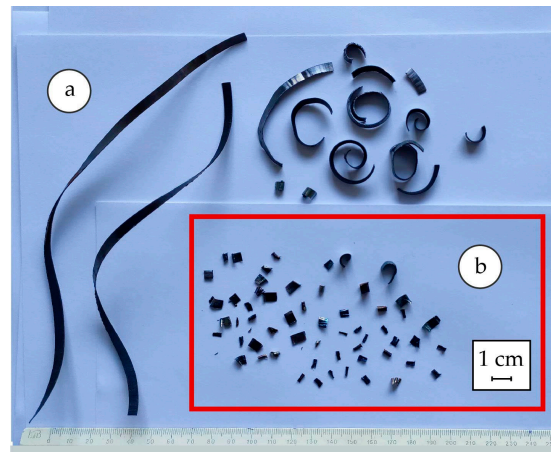
The presence of absorbed hydrogen in steel at amounts of 6–8 ppm contributes to the formation of fine chips regardless of the turning frequency (Figure 19). The macroimages of hydrogenated chips are shown in [7]. They are characterized by a significant number of cracks compared to the chips that were separated from non-hydrogenated specimens. The use of computer vision technology allows us to determine the presence of such damage and draw a conclusion about the condition of the material.

Figure 19. Chips formed during dry cutting at 315 RPM: before hydrogenating (a); after hydrogenating (b).

The formation of a larger number of cracks in the hydrogenated material can be attributed to the influence of hydrogen penetrating into the surface and subsurface layers. The temperature increase, intensification of plastic deformation, and presence of pores in the material affect the state and distribution of hydrogen. Molecular hydrogen accumulates in the pores and creates high pressures that contribute to steel embrittlement. The presence of hydride-forming elements can contribute to the retention of atomic hydrogen in steel [90]. Thus, a thorough diagnosis and fractographic analysis of the chips allow us to draw conclusions about the formation of chips under the complex influence of factors.
