# Engineering Failure Analysis

## The effect of short circuits and flame temperature modes on the change in the microstructure of copper in automotive wiring

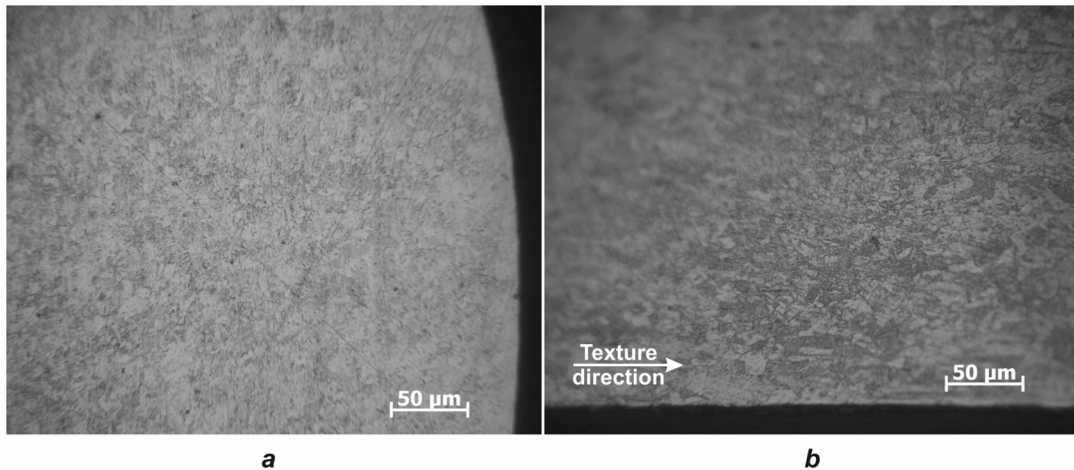
OM images of crosswise and lengthwise surfaces of the copper wire in its original state are shown in Fig. 4. It can be seen that the samples consist of polycrystalline grains elongated along a line, coinciding with the direction of wire-drawing [24,25]. It is noteworthy that in the crosswise microsection (Fig. 4, a) grains of the original copper are almost invisible, while in the lengthwise microsection (Fig. 4, b) those are quite clearly visible. The reason for this is the threadlike shape of the grains obtained by wire-drawing.

Fig. 4. OM images of the original copper wire surface: (a) crosswise microsection, (b) lengthwise microsection (the arrow indicates the direction of wire drawing).

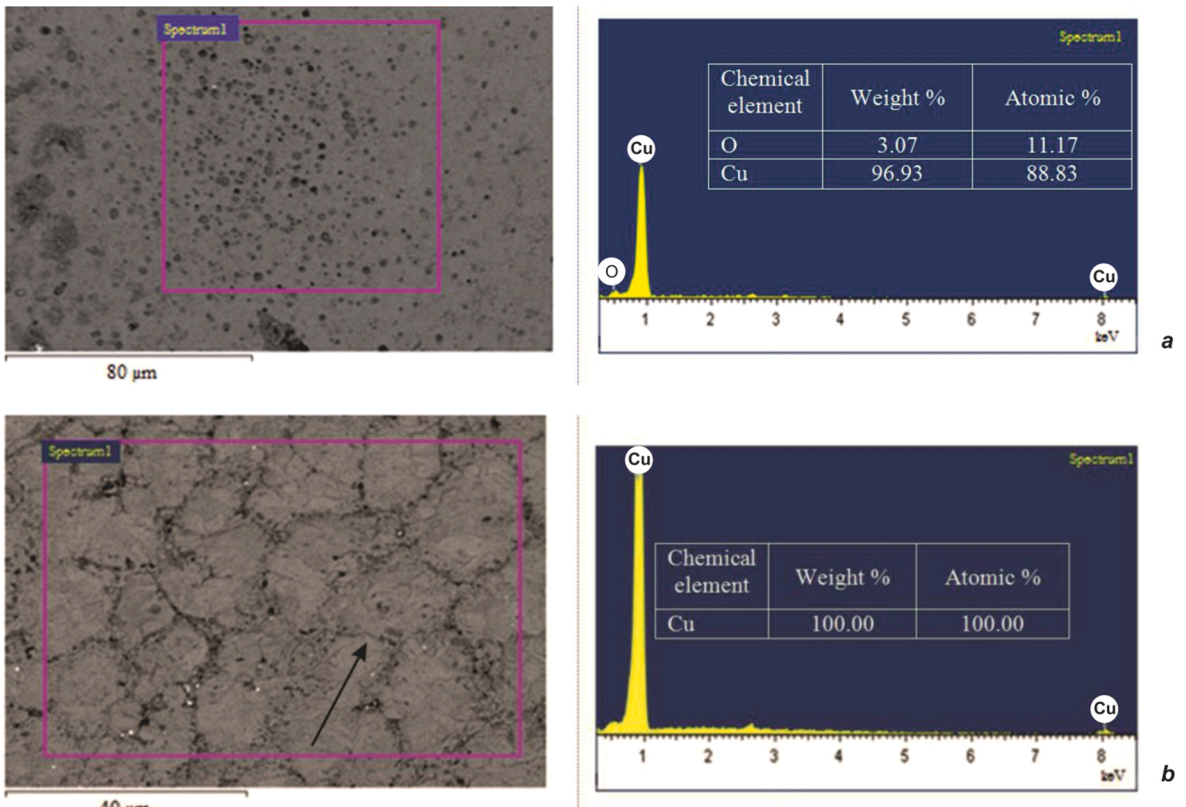
The image of the microstructures of the original copper wires visualized by SEM and EDX results is shown in Fig. 5. It is interesting that on the crosswise microsection (Fig. 5, a) rounded grains of almost the same size (average linear intercept (L) is ~15–20 μm, equivalent ASTM grain-size number (G) is no. 8 [26]) are also barely noticeable, while grains in lengthwise microsection already are clearly visible (Fig. 5 (b)). Small dark spots on the crosswise microsection apparently belong to copper(II) oxide. The grains in lengthwise microsection have a slightly elongated shape oriented in the direction of wire-drawing. In some areas of the surface of lengthwise microsections, there are grains whose sizes (L = ~30 μm, G = no. 7–6) exceed the average size of most grains.

The grains within the selected area of the crosswise microsection contain 96.93 wt% copper and 3.07 wt% oxygen (Fig. 5 (a) (at the right)), and the grains of the lengthwise microsection consist only copper (Fig. 5 (b) (at the right)). The actual absence of traces of oxygen in the lengthwise microsection is due to the presence of insulation, which hermetically covers the surface of the initial copper wire and thus protects it from oxidation by air oxygen.

Fig. 5. SEM images showing the areas where the EDX analysis was applied on samples of the original copper wire: (a) crosswise microsection, (b) lengthwise microsection (the arrow indicates the direction of wire drawing). To the right of the SEM images, the relative signals of copper and oxygen are shown.

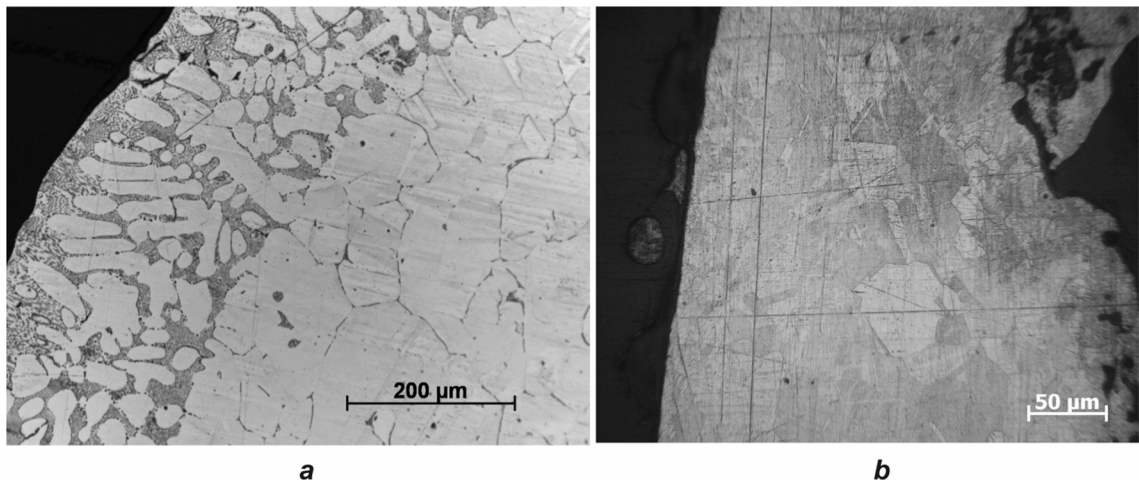
OM images of crosswise and lengthwise microsections demonstrating changes of microstructure for copper wire samples that experienced short circuit current, with a density of 30–60 A·mm<sup>-2</sup> is presented in Fig. 6. Under conditions of short-term high-temperature exposure (short-circuit effect), the microstructure of copper wire undergoes significant changes. These changes are mainly related to the grain morphology and are determined by the cooling rate of the samples. Thus, Fig. 6, a shows a peculiar dendritic grain structure that has arisen in the surface layer of copper wire, where fast and efficient heat removal is possible. Darker areas belonging to

Fig. 6. OM images of copper wire samples having been undergone the short circuit impact: (a) crosswise microsection, (b) lengthwise microsection.

copper(II) oxide are also visible between the dendritic formations. On the contrary, the inside of the copper wire does not cool as quickly as the outside. Under these conditions, the threadlike grains, which previously belonged to the copper wire in the original state, are significantly enlarged (see Fig. 6, a). On the other hand, copper wires can instantly melt under the action of short-circuit currents with a density of  $>30 \text{ A}\cdot\text{mm}^{-2}$ . As a result of this, peculiar beads and pits may appear on the surface of the copper wire (Fig. 6, b). These local spherical formations (beads and pits) are especially clearly visible on SEM images (see Fig. 7). At that, these formations occur both in crosswise and lengthwise microsections (Fig. 7, a and b). It should be noted that due to a short circuit, these formations are localized in the places where an electric arc occurred, which caused melting and even partial boiling of copper. Moreover, when a direct current of a higher density is passed, the number of such surface defects, as well as their sizes ( $L = 30\text{--}50 \text{ }\mu\text{m}$ ), increase noticeably.

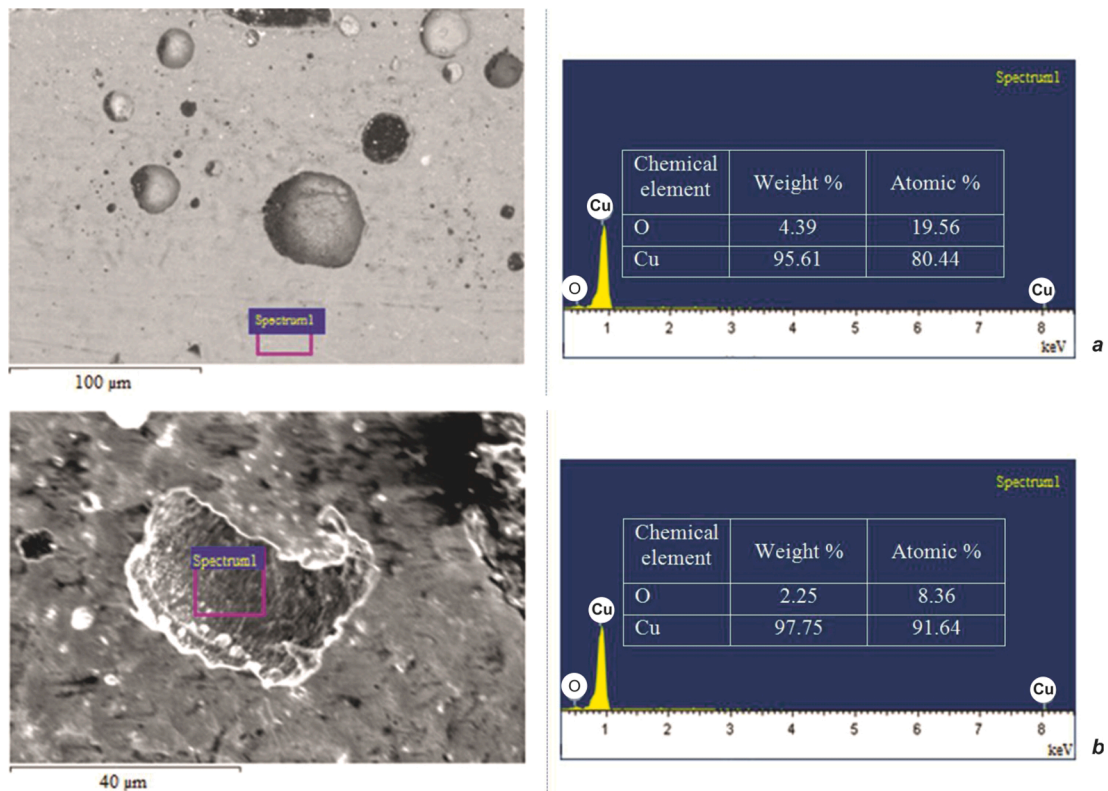
Under the action of high-density direct current, the elemental composition of grains on the surface of the copper wire changes compared to the original copper wire. The grains on the crosswise microsection contain 95.61 wt% copper and 4.39 wt% oxygen. But in the spots where copper melts and even boils, the oxygen content increases to 27.18 wt%, and the copper content accordingly decreases to 72.82 wt%. However, the grains of the lengthwise microsection contain 97.75 wt% copper and 2.25 wt% oxygen.

Fig. 7. SEM images showing the areas where the EDX analysis was applied on the sample of copper wires having been undergone the short circuit impact: (a) crosswise microsection, (b) lengthwise microsection. To the right of the SEM images, the relative signals of copper and oxygen are shown.

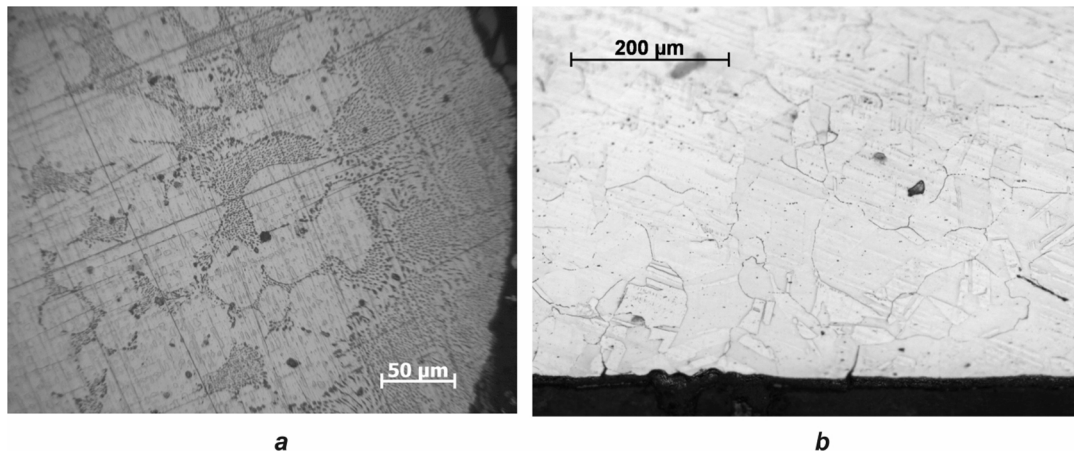
OM images of copper wire samples exposed to an open flame are shown in Fig. 8. In the case of a long-time stay of copper wires in a high-temperature oxidizing medium (flame exposure), the pattern change of the microstructure will differ from that at a short circuit. In this regard, a microphotograph of the crosswise microsection of copper wires which had been in flame for a long time turned out to be very indicative. Thus, the dendritic structure of grains is completely absent on the outer surface of such a wire (Fig. 8, a). Instead, we see oxidized copper that penetrates from the outside into the inside of the wire (darker surface layer). This is the result of a long-time exposure to the copper wire of a very aggressive oxidizing agent – air oxygen. At the same time, the inner part of the copper wire, from which heat removal is difficult, consists mainly of coarse grains. Apparently, the observed grain growth is the result of diffusion processes, which increase with elevating temperature. Such a coarse-grained microstructure is especially clearly visible on the lengthwise microsection (see Fig. 8, b).

Fig. 8. OM images of copper wire samples having been exposed to an open flame: (a) crosswise microsection, (b) lengthwise microsection.

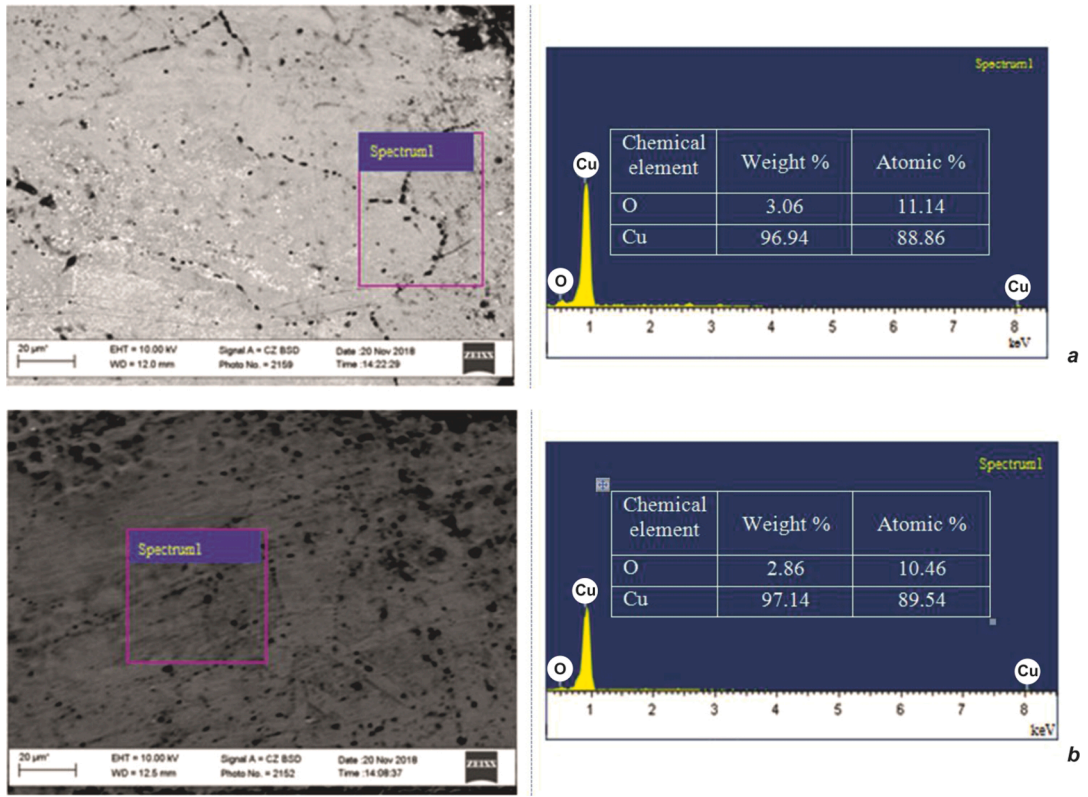
SEM images of crosswise and lengthwise microsections of copper wire samples exposed to an open flame are shown in Fig. 9. The images demonstrate the transformation of the fine-grained microstructure of original copper wires into a coarse-grained one during

exposure to a flame. In this process, the linear sizes of the grain increase by about 10 times ( $L = 150\text{--}200\ \mu\text{m}$ ;  $G = \text{no. } 2$ ). This applies equally to both the crosswise (Fig. 9, a) and the lengthwise (Fig. 9, b) microsections.

The Cu and O content in the grains of the crosswise microsections is 96.94 and 3.06 wt%, respectively (Fig. 9, a (right)), and in the grains of lengthwise microsections it is somewhat lower and amounts 2.86 wt% and 97.14 wt% for O and Cu, respectively (Fig. 9, b (right)).

Fig. 9. SEM images showing the areas where the EDX analysis was applied on the sample of copper wires having been exposed to an open flame: (a) crosswise microsection, (b) lengthwise microsection. To the right of the SEM images, the relative signals of copper and oxygen are shown.

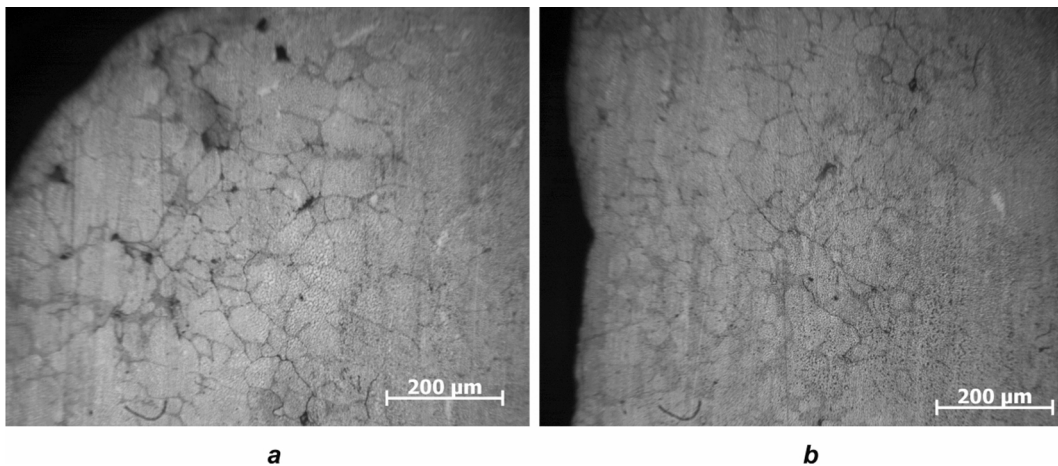
OM images of crosswise and lengthwise microsections of copper wire samples after the combined effect of a short circuit and flame are shown in Fig. 10. It is easy to see that the microstructure of copper wires, previously short-circuited and then exposed to an open flame, has an extremely interesting structure of grains. Under conditions of first short-term high-temperature exposure (short-circuit effect), and then long-term exposure to copper wires of a high-temperature oxidizing environment (flame exposure), the fine-grained microstructure of the original copper wire is transformed in a characteristic coarse-grained microstructure is formed, within which the formed grains are separated by dark boundaries of copper(II) oxide. Moreover, the closer the grains are to the surface layer of the wire, the brighter their oxidized boundaries appear. This is especially well seen in the crosswise microsection (see Fig. 10, a). Such a microstructure pattern results from coarsening the dendritic formations that appear in the surface layer of copper wire after a short-term high-temperature exposure (see Section 3.2). Thereupon, the temperature mode of flame, which was applied to copper wires after a short circuit effect, should be considered as a kind of recrystallization annealing, resulting in full recovery of the equilibrium coarse-grained microstructure of copper. It should be noted that the linear dimensions of the grains formed both under the action of fire only and under the combined action of short circuit and fire are practically the same (compare Fig. 8, b and 10, b). Apparently, the oxidation of grains at their boundaries occurs much more efficiently under combined action.

Fig. 10. OM images of copper wire samples having been undergone the combined action of the short circuit and flame: (a) crosswise microsection, (b) lengthwise microsection.

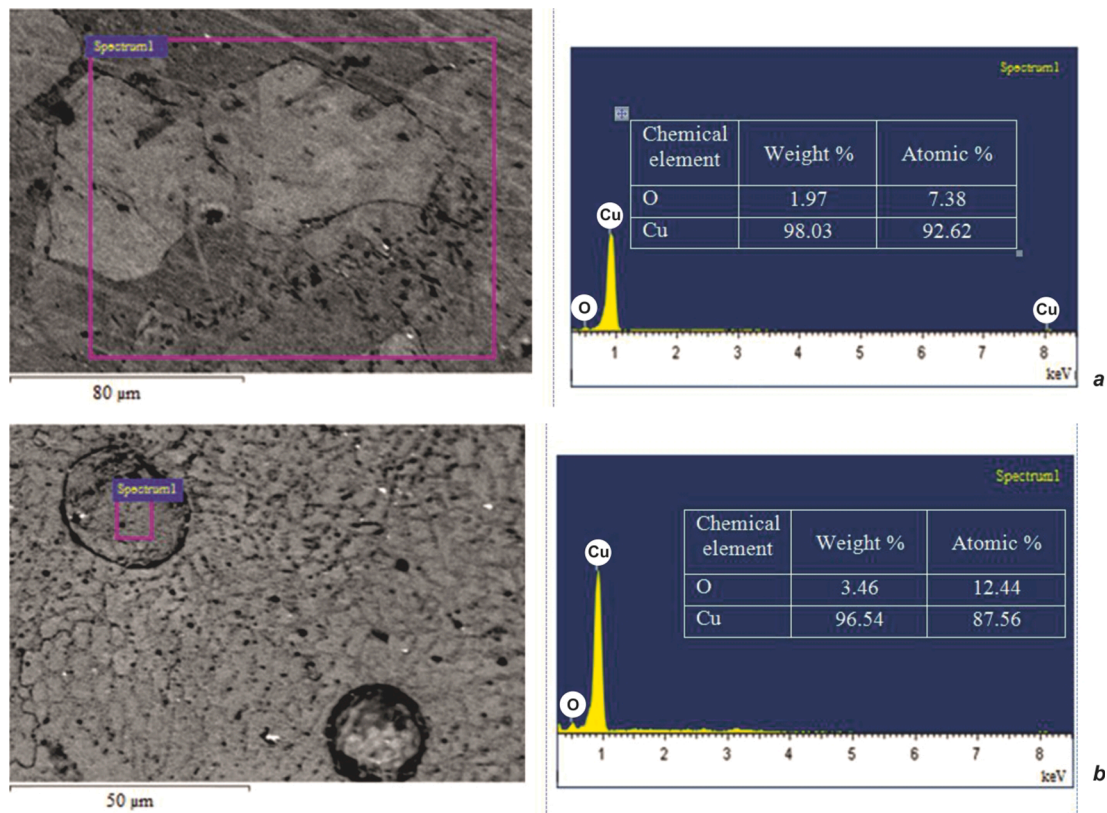
The results of SEM microphotography of crosswise and lengthwise microsections of copper wire samples after combined exposure are shown in Fig. 11. Like the OM data, the SEM results confirm that the initial microstructure of the copper wire, due to the combined action of short circuit and fire, is transformed into a special coarse-grained microstructure, in which oxidized copper is formed at the grain boundary (see Fig. 11, a). Also in the Fig. 11, b, local spherical inclusions (beads and pits) formed during a short circuit are visible. The EDX analysis showed that grains of crosswise microsections contain 98.03 wt% of copper and 1.97 wt% of oxygen. The O content in grains of lengthwise microsections is some higher and is 3.46 wt%, and the Cu content is 96.54 wt%.

**Fig. 11.** SEM images showing the areas where the EDX analysis was applied on the sample of copper wires having been undergone the combined action of the short circuit and flame: (a) crosswise microsection, (b) lengthwise microsection. To the right of the SEM images, the relative signals of copper and oxygen are shown.
