Engineering Failure Analysis

The effect of short circuits and flame temperature modes on the change in the microstructure of copper in automotive wiring

<https://doi.org/10.1016/j.engfailanal.2022.106198>

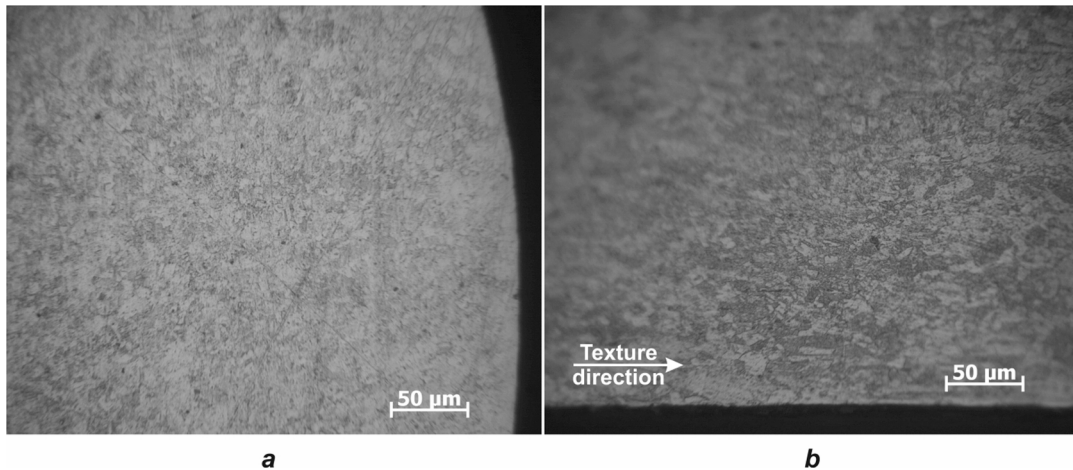
OM images of crosswise and lengthwise surfaces of the copper wire in its original state are shown in Fig. 4. It can be seen that the samples consist of polycrystalline grains elongated along a line, coinciding with the direction of wire-drawing [24,25]. It is noteworthy that in the crosswise microsection (Fig. 4, a) grains of the original copper are almost invisible, while in the lengthwise microsection (Fig. 4, b) those are quite clearly visible. The reason for this is the threadlike shape of the grains obtained by wire-drawing.

Fig. 4. OM images of the original copper wire surface: (a) crosswise microsection, (b) lengthwise microsection (the arrow indicates the direction of wire drawing).

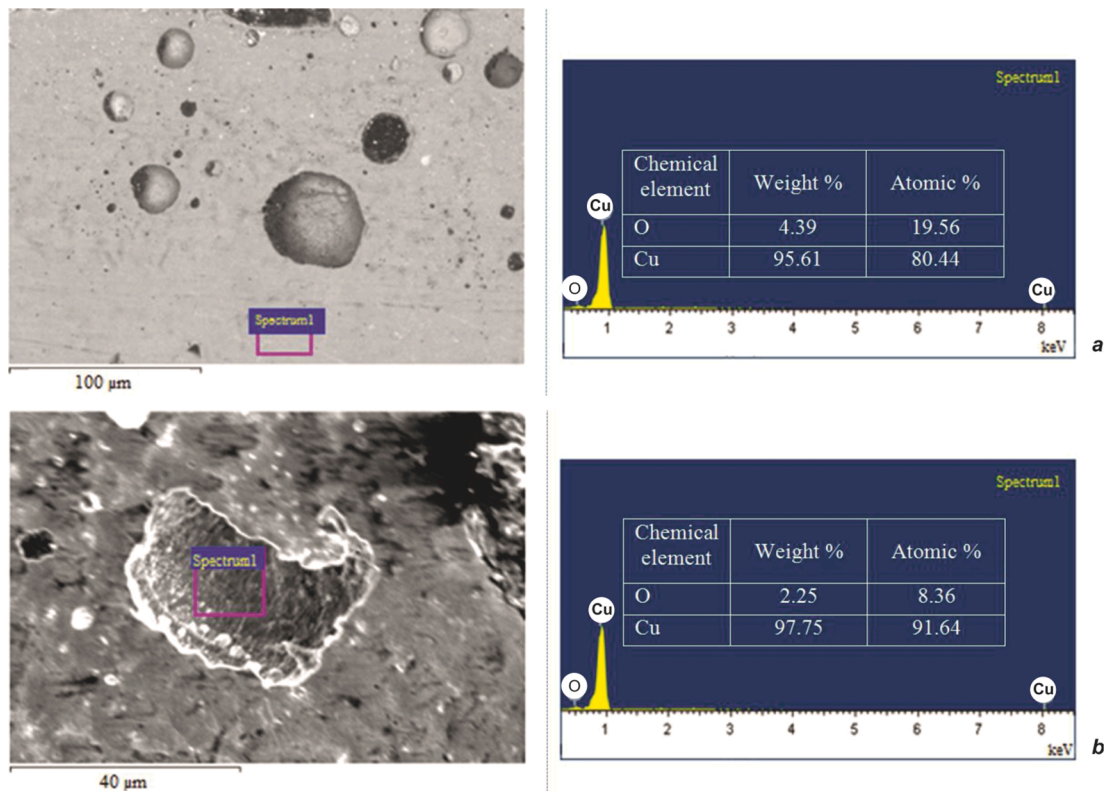
Under the action of high-density direct current, the elemental composition of grains on the surface of the copper wire changes compared to the original copper wire. The grains on the crosswise microsection contain 95.61 wt% copper and 4.39 wt% oxygen. But in the spots where copper melts and even boils, the oxygen content increases to 27.18 wt%, and the copper content accordingly decreases to 72.82 wt%. However, the grains of the lengthwise microsection contain 97.75 wt% copper and 2.25 wt% oxygen.

Fig. 7. SEM images showing the areas where the EDX analysis was applied on the sample of copper wires having been undergone the short circuit impact: (a) crosswise microsection, (b) lengthwise microsection. To the right of the SEM images, the relative signals of copper and oxygen are shown.

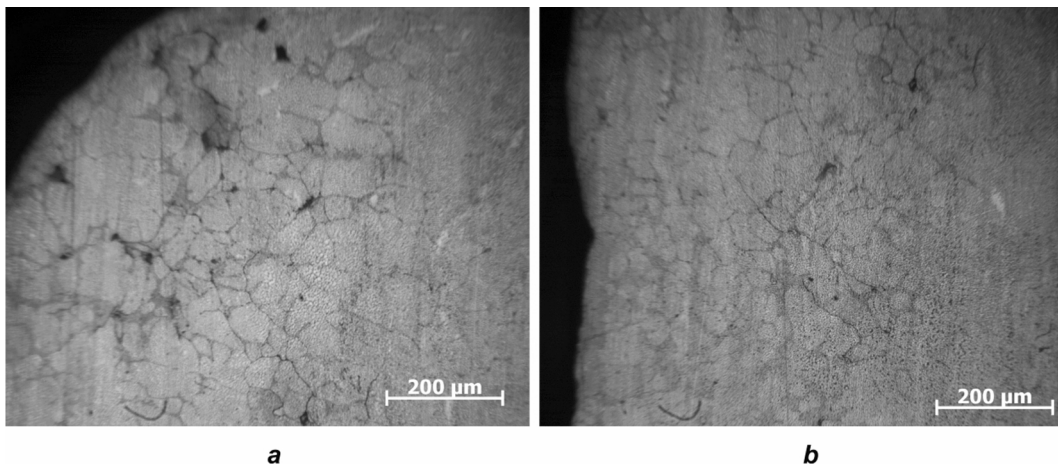
OM images of crosswise and lengthwise microsections of copper wire samples after the combined effect of a short circuit and flame are shown in Fig. 10. It is easy to see that the microstructure of copper wires, previously short-circuited and then exposed to an open flame, has an extremely interesting structure of grains. Under conditions of first short-term high-temperature exposure (short-circuit effect), and then long-term exposure to copper wires of a high-temperature oxidizing environment (flame exposure), the fine-grained microstructure of the original copper wire is transformed in a characteristic coarse-grained microstructure is formed, within which the formed grains are separated by dark boundaries of copper(II) oxide. Moreover, the closer the grains are to the surface layer of the wire, the brighter their oxidized boundaries appear. This is especially well seen in the crosswise microsection (see Fig. 10, a). Such a microstructure pattern results from coarsening the dendritic formations that appear in the surface layer of copper wire after a short-term high-temperature exposure (see Section 3.2). Thereupon, the temperature mode of flame, which was applied to copper wires after a short circuit effect, should be considered as a kind of recrystallization annealing, resulting in full recovery of the equilibrium coarse-grained microstructure of copper. It should be noted that the linear dimensions of the grains formed both under the action of fire only and under the combined action of short circuit and fire are practically the same (compare Fig. 8, b and 10, b). Apparently, the oxidation of grains at their boundaries occurs much more efficiently under combined action.

Fig. 10. OM images of copper wire samples having been undergone the combined action of the short circuit and flame: (a) crosswise microsection, (b) lengthwise microsection.
