Natural phytomelioration of coal mine waste heaps in the context of increased radiation background (on the case of Nadiya mine, Lviv-Volyn coal basin, Ukraine)

A I Voloshchyshyn, P V Bosak, V V Popovych, O V Menshykova and Yu O Kopystynskyi

Lviv State University of Life Safety, 35 Kleparivska Str., Lviv, 79007, Ukraine

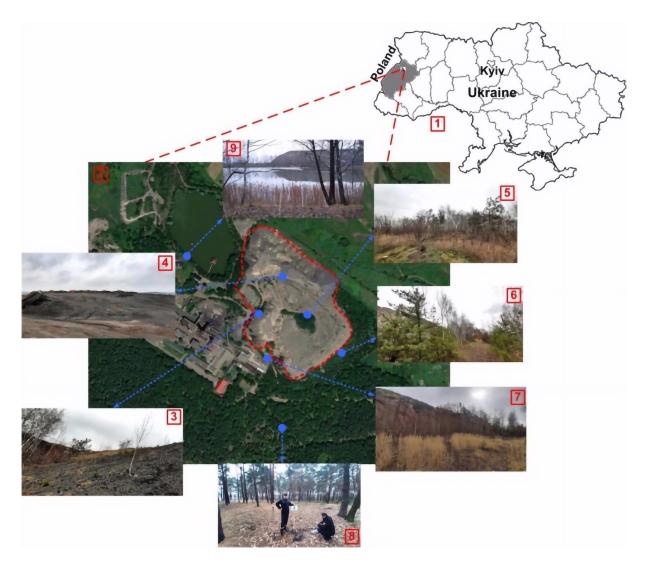
Figure 1. Location of the study site: 1 – map of Ukraine with the designation of the Nadiya mine; 2 – image of the waste heap of the Nadiya mine using GoogleMaps; 3-9 – sampling points.

We chose 7 different sites near the Nadiya mine to analyze the environmental situation and take substrate samples for radiation background analysis. The samples were taken from depths of 0-15 cm and 0-20 cm, as well as from an anthropogenic reservoir which accumulated the waste formed from anthropogenic activities (figure 1).

Seven study areas of the Nadiya mine were selected to study the radiation background of the waste heap, since the combustion process was observed there: 1 - at the foot of the spoil heap in relatively favorable growth conditions; 2 - on the slope, where intensive water-erosion outcrops 1-2 m wide and 0.5-1 m deep are present; 3 - on the terraced slope, with numerous places of water-erosion outcrops (1-1.5 m wide, 0.5-1 m in width, 0.5-1 m in depth), deflation (wind erosion), places of fire, discharge of fuels and lubricants, household waste, as well as increased soil cover density, and as a result, almost complete absence of above-ground grass cover; 4 - at the foot of the spoil heap of the forest area, in some places there are traces of soil washout and exposure of tree root systems (danger of tree fall); 5 - on the top of the waste heap, mostly flat with small hilly areas and minor relief depressions; 6 - control, at a distance of 3 km from the waste heap in the forest area with practically no anthropogenic impact (there are natural forest roads); 7 - from an anthropogenic reservoir, at a distance of 2 km from the western side of the waste heap.

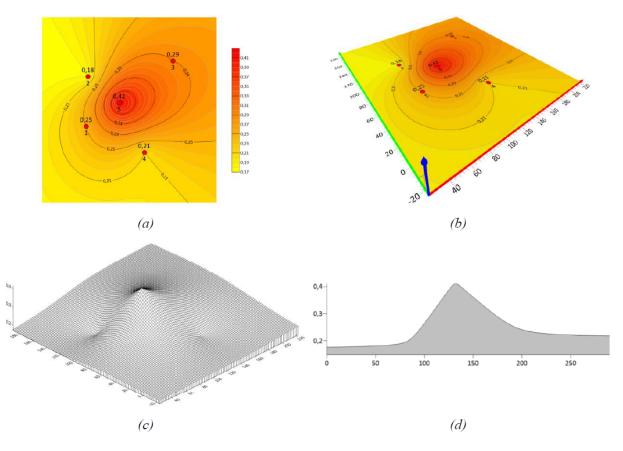
Figure 4. Radiation background propagation in the edaphic horizons of the Nadiya mine waste heap, μ Sv/h ((a), (b) – spread of the highest equivalent dose rate of photon ionizing radiation; (c), (d) – mine waste heap horizon 0-0.5 m).

Researchers say that burning waste rock can lead to an increase in the radiation background [22]. According to the studies, it was confirmed that the radiation power on the top and slopes of the Nadiya mine spoil heap, where the heap is burned, is much higher than in other areas [23]. The study of the radiation background of the investigated waste heap showed an average equivalent dose rate on the surface of the decaying waste heap of 0.27 μ Sv/h, which does not exceed the radiation safety standards but exceeds the background values for the region [24, 25]. The modeling of radiation background propagation in the edaphic horizons of the Nadiya mine waste heap is shown in (figure 4).

The results of modeling the spread of radiation background are consistent with the data of phytocoenological studies. The slopes exhibit a multitude of instances of erosion caused by wind and water, fire-prone areas, release of household waste, fuel and lubricants, and high-intensity water erosion.
