To cite this article: A I Voloshchyshyn *et al* 2024 *IOP Conf. Ser.: Earth Environ. Sci.* **1415** 012130

Natural phytomelioration of coal mine waste heaps in the context of increased radiation background (on the case of Nadiya mine, Lviv-Volyn coal basin, Ukraine)

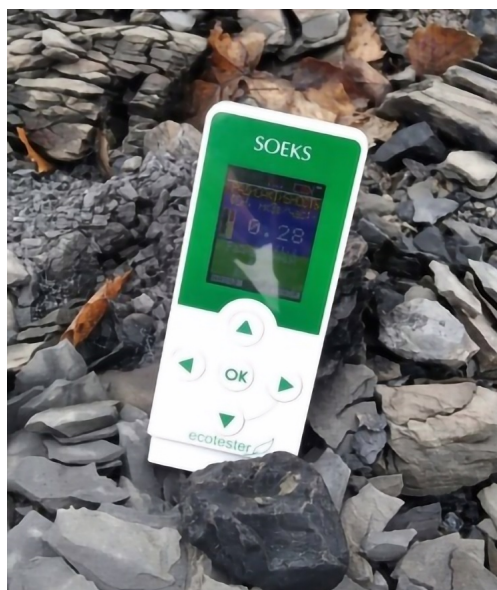
Figure 2. SOEKS environmental tester operation.

The radiation levels of the waste heaps were measured with the SOEKS environmental tester (shown in figure 2) in compliance with the guidelines of Ukraine's Radiation Safety Standards (NRBU-93) [21]. Modeling of radiation background is carried out using computer program Surfer. The intensity of illumination was determined using a digital luxmeter with a remote sensor (model LX1010BS, measuring range 1–100000 Lx), measurement accuracy $\pm 4\%$ operating temperature of the environment $-10^{\circ}\text{C} \dots +50^{\circ}\text{C}$. Humidity and air temperature were determined using a UNI-T UT333 digital thermo-hygrometer (humidity 0–100% temperature: $-10^{\circ}\text{C} \dots +60^{\circ}\text{C}$), error $\pm 1^{\circ}\text{C} / \pm 5\%$. The wind speed was measured using a mini-anemometer HT-383, measurement accuracy ± 1.5 m/s, measurement range 0–30 m/s. The substrate temperature was measured using an AMT-300 analyzer, temperature error $\pm 1^{\circ}\text{C}$, measuring range from $+9^{\circ}\text{C}$ to $+50^{\circ}\text{C}$.

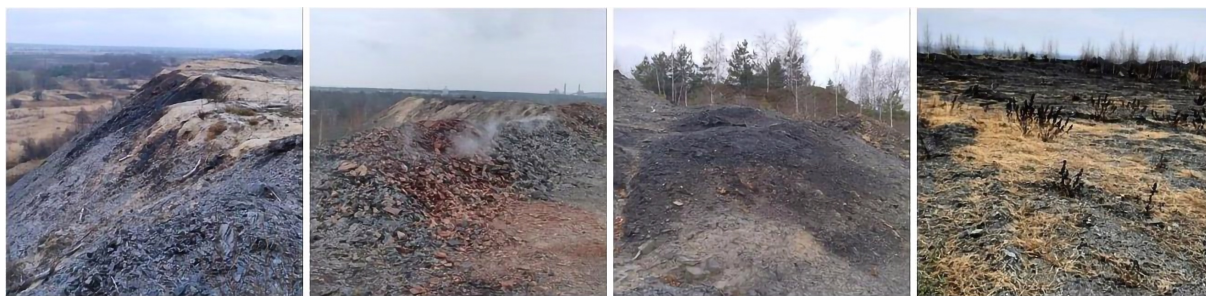
Figure 3. Results of burning certain areas of the waste heap at Nadiya mine (photo by A. Voloshchyshyn and P. Bosak)

dose rate were observed near the burning areas of certain parts of the waste heap and amounted to 0.21, 0.25, 0.29 and 0.42 $\mu\text{Sv/h}$ (figure 3). The lowest values were recorded in the forest area 3 km from the waste heap and near the man-made reservoir 2 km from the waste heap, which amounted to 0.12 and 0.17 $\mu\text{Sv/h}$.
