The Effect of Absorbed Hydrogen on the Rotors of Steel Machining Products During Powerful Turbo Aggregate Repairs

Abstract: Rotor shafts are the most heavily loaded and accident-prone parts of powerful turbine generators, which are cooled using hydrogen. To eliminate damage sustained during operations, repair work was carried out, including the removal of defective parts, surfacing, and turning. This study tested the machinability of the rotor shaft using prototypes made from 38KhN3MFA steel. A section of the shaft was degraded due to prolonged operation (250 thousand hours), and compared to the central part, a decrease in the average grain size from 21.57 μm to 12.72 μm and an increase in the amount of hydrogen absorbed during operation from 2.27 to 7.54 ppm were observed. With the frequency of dry turning increasing from 200 to 315 RPM, the chips changed their form from mostly rectangular with linear dimensions of 10 to 20 mm to large spiral rings with a diameter of 15 to 20 mm and a length of more than 50 mm. Cracks of 1 to 4 mm in length were found in most chip particles at both rotational speeds. Increasing the rotational speed from 200 to 315 and up to 500 RPM led to the for

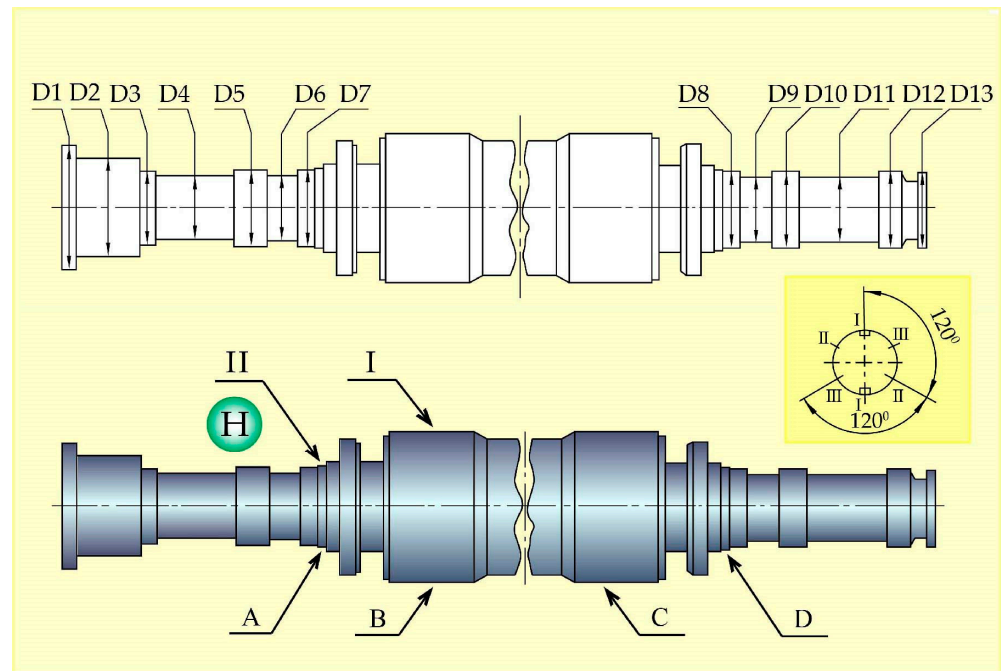
The dimensions of the individual sections of the rotor shaft are shown in Table 3, and the conceptual diagram of the TG shaft is shown in Figure 7. Arrow I shows the area in which significant degradation processes are not recorded, and the microstructure of this zone corresponds to the initial conditional state (Figures 7 and 8a). Arrow II schematically shows the place of destruction of the hydrogen seal, where microstructural changes were recorded (Figures 7 and 8b). Here, in the zone of maximum hydrogen exposure, an increase in the microhardness of the shaft was found (Table 4).

Figure 7. Schematic of the rotor shaft. Test area I—central part, which corresponds to the initial condition; Test area II—hydrogen seal. H—hydrogen, A, B, C, D—microhardness measurement locations (Table 4), D1–D13—rotor section diameters (Table 3).

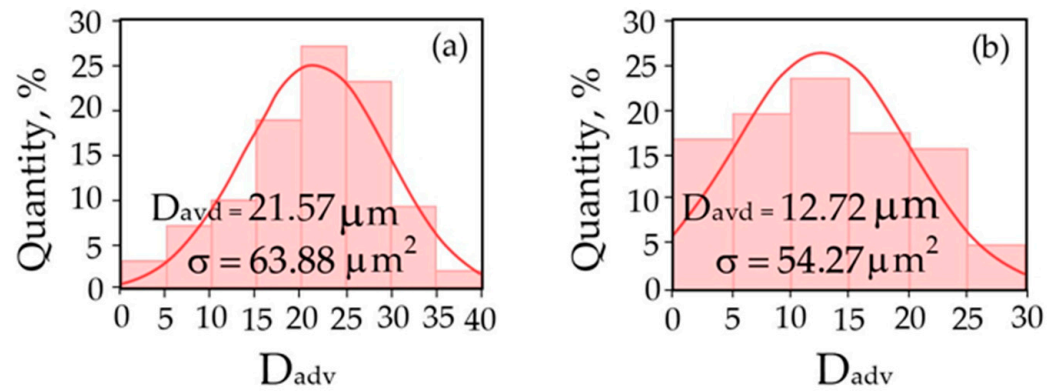
For site I, the average grain size was $D = 21.57 \mu\text{m}$, and the variance was $\sigma = 63.88 \mu\text{m}^2$; for site II, the average grain size was $D = 12.72 \mu\text{m}$, and the variance was $\sigma = 54.27 \mu\text{m}^2$. The largest average values of the data shown in the histograms (the central columns through which the maximum (extremum) of the normal distribution 2D RVE passes) correspond to 6, 7, and 8 (Figure 9a) and 9, 10, and 11 points of grain size (Figure 9b) according to DSTU 8972:2019 [87]. After machining and obtaining chips from areas I and II, the amount of hydrogen was determined to be 2.27 and 4.72 ppm (Figure 10a,b).

Figure 9. Histograms with the distribution of inclusion sizes (a,b). Initial condition of the rotor shaft surface (I—(a)); state in the hydrogen seal zone (II—(b)).

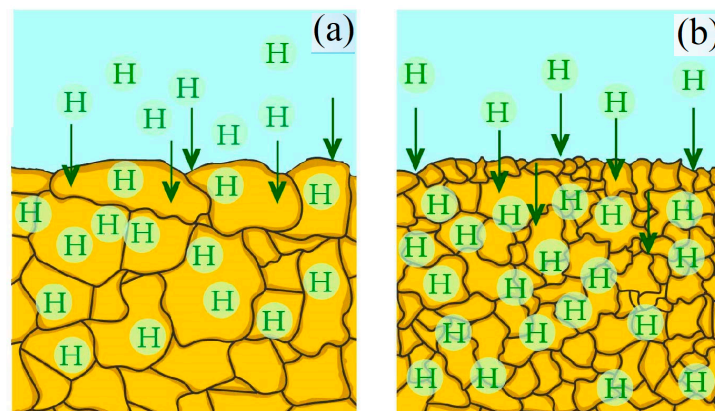
Figure 11a,b show a schematic diagram that considers a scenario where a larger amount of hydrogen is fixed in the finer microstructure of the rotor shaft. During long-term operation, the rotor shaft comes into contact with a hydrogen-containing medium that cools the rotor shaft, and due to newly formed defects and damage due to the presence or formation of a thinner microstructure, the hydrogen saturation of the surface and near-surface layers occurs.

Figure 11. Scheme of microstructure: the initial conditional state of the rotor shaft surface (I—(a)); the state in the hydrogen seal zone (II—(b)).

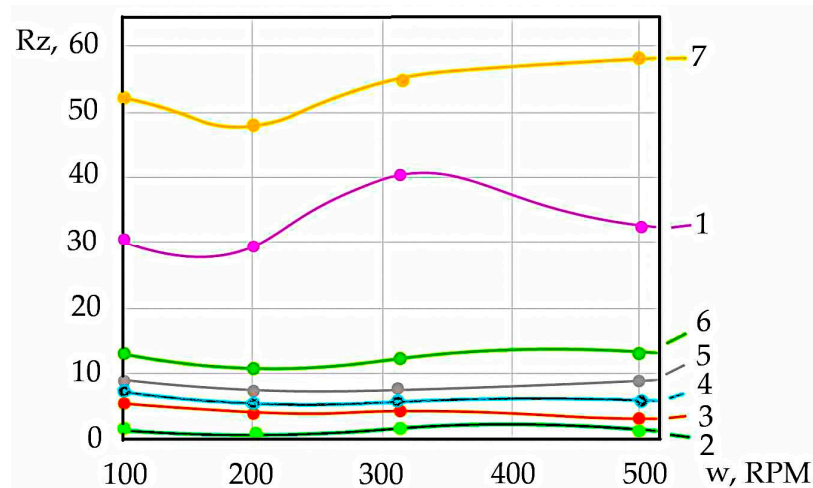
The surface roughness after turning specimens from 38KhN3MFA steel depends on the rotational speed (Figure 20). It is recorded that at 100 RPM, the roughness is greater than at 200 RPM, which is explained by the fact that under such conditions, an outgrowth formed between the cutter and the workpiece, which interfered with finishing. An increase in the temperature in the cutting zone at 315 RPM contributed to an increase in roughness, but further increases in speed led to a more uniform removal of workpiece material and a decrease in roughness (curves 1, 2, 3, 4, 6, and 7). This pattern was particularly clear under dry cutting conditions for the specimen with ferrite–pearlite microstructure (curve 1). The highest roughness was observed for the specimen cut from the degraded part of the shaft (curves 5 and 6). This can be explained by the fact that during the interaction of the surface and subsurface layers of the rotor shaft during operation, complex physical and chemical processes are reflected as a result of long-term processes that lead to structural changes. For example, for turbine unit shafts, it was recorded that during long-term operation (up to 250 thousand hours), the surface hardness of the rotor shaft decreases from 290 HB to 250 HB. It was recorded that in the microstructure of the shaft, the amount of cementite decreased from 87% to 62%, and the proportion of free ferrite increased from 5% to 20% over 250 thousand hours of operation. The average microhardness of ferrite decreased from 1.9 GPa to 1.5 GPa. An increase in the content of alloying elements in carbides was recorded: Cr and V—by 1.15–1.6 times; Mo—by 2.2–2.8 times [7,91,92]. The hydrogen saturation of the specimen with a sorbitan microstructure at a hydrogen concentration of 2 ppm reduced the surface roughness compared to the non-saturated specimen. At such lower hydrogen concentrations, the “plasticising effect” of hydrogen in the steel matrix was observed [85,93,94]. For specimens with a hydrogen concentration of 6 and 8 ppm, the

microhardness (Table 4) and roughness (Figure 20; curves 4 and 5) were higher than for the unhydrogenated sample, indicating the brittle nature of the hydrogen effect. Also, the embrittling effect of hydrogen [7,9,82,85,86] is confirmed by a decrease in the values of δ and ψ after the saturation of the specimens with hydrogen (Tables 1 and 2).

Figure 20. Graph of surface roughness: 1 and 2—conditionally initial condition; 3, 4, and 5—experimental prototypes after gas hydrogenation: hydrogen concentration 2, 4, and 5 ppm, respectively; 6 and 7—specimens from the degraded part of the rotor shaft (6 and 7.54 ppm, respectively). Cutting conditions: 1 and 7—dry cutting; 2–6—cutting with coolant.
