Engineering Failure Analysis

The effect of short circuits and flame temperature modes on the change in the microstructure of copper in automotive wiring

<https://doi.org/10.1016/j.engfailanal.2022.106198>

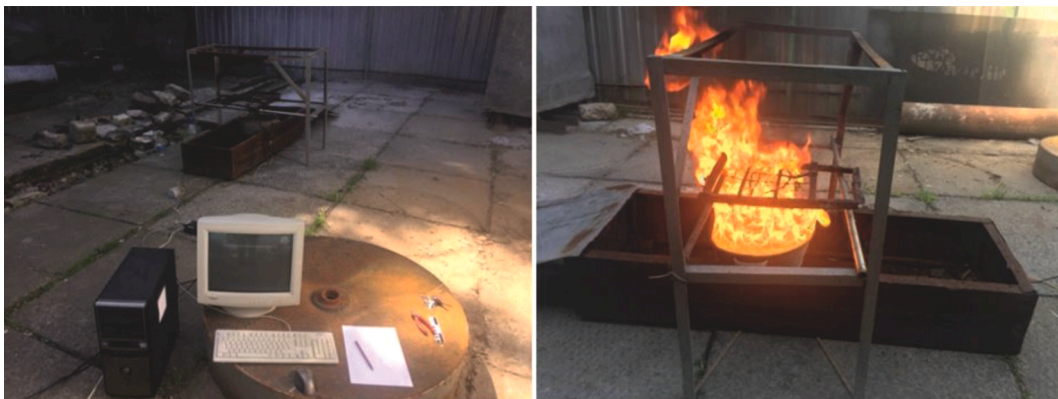
The test samples of both the original copper wires (previously not exposed to any impact) and the wires that had previously been exposed to a short circuit are placed above the flame (Fig. 1).

Fig. 1. An experimental installation for testing copper wires with an open flame.

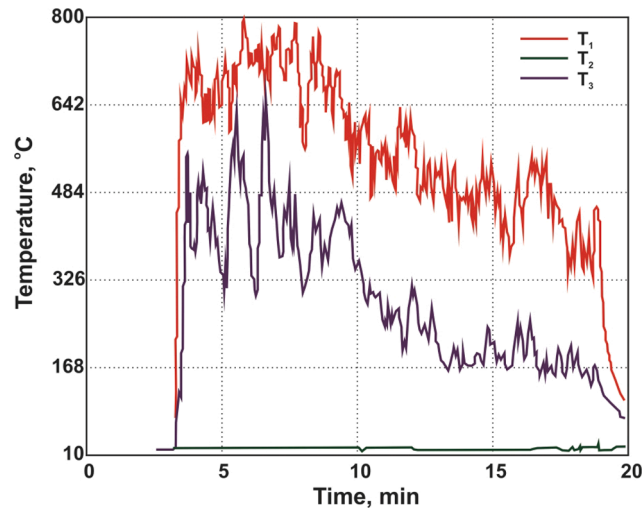
The flame temperature in the area of the copper wires was measured by thermocouples, the signals from which were transmitted to the personal computer. The experimental dependence of changes in the temperature modes of the flame on time is shown in Fig. 2. The temperature characteristics generated by the seat of fire of the class 8B were used to study the effect of open flame on copper current-conducting systems of cars

Fig. 2. Flame temperature modes versus time: T₁ – temperature near copper wires; T₂ – ambient temperature; T₃ – temperature over flame (the flame is generated with a seat of fire of class 8B).

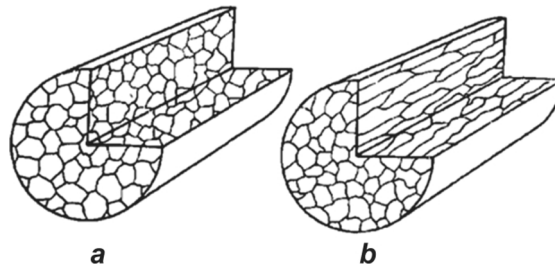
Fig. 3. Shape of grains in crosswise and lengthwise microsections: (a) equiaxed, (b) elongated along the direction of wire drawing.
